### Residential Property Inspections

Property Condition Report for: 555 Anywhere Avenue, Santa Rosa CA

# CRAWLSPACE & FOUNDATION

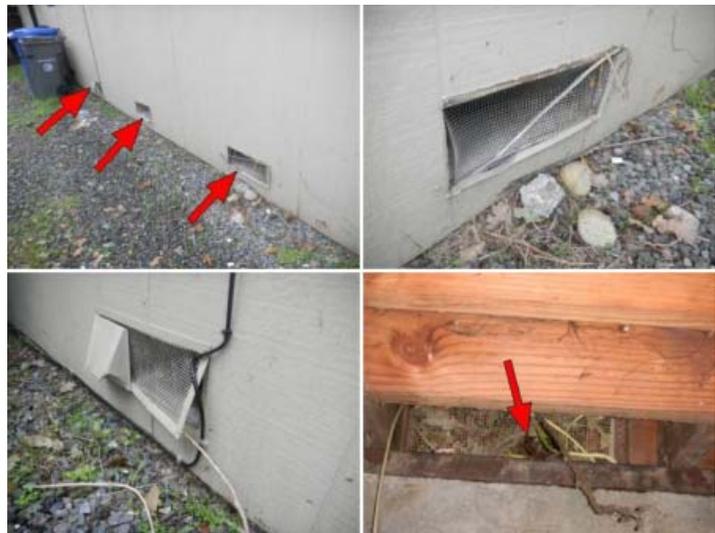
One or more foundation vent screens are damaged or missing. This may allow rodents and animals access to the under-floor crawlspace. Recommend repairing any openings in the screens.

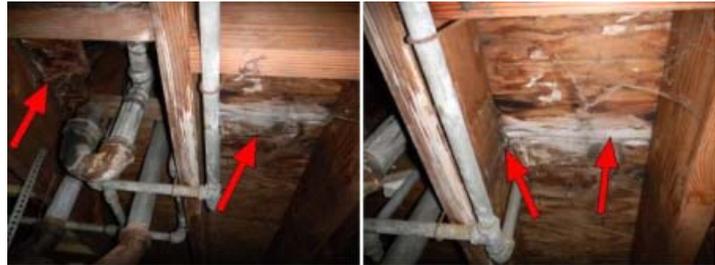
**SUBFLOOR:** Good to Fair Condition.  
Plywood.  
Staining and deterioration is noted to the sub-flooring or framing components under the bathrooms. Repairs have been made to some areas of the flooring. These stains appear to be from a past moisture challenge however we cannot be absolutely sure. Recommend having this condition evaluated and corrected by the appropriate qualified trades person.
