# EXTERIOR & GARAGE

### Property Condition Report for: 555 Anywhere Avenue, Santa Rosa CA

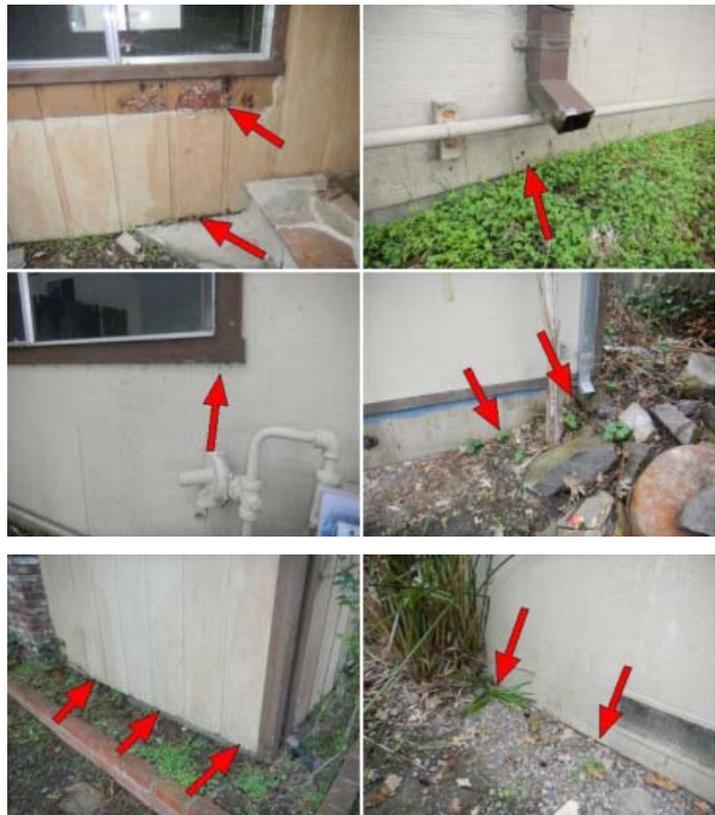
Damage or deterioration from moisture is noted to the siding at one or more locations around the structure (see pictures for examples).

Siding is weathered in some areas around the structure.  
Wood members were noted which are in contact with the soil or concrete. This condition will have an adverse affect on the duration of wood components. It is recommended to have adequate separation between the ground and siding components.

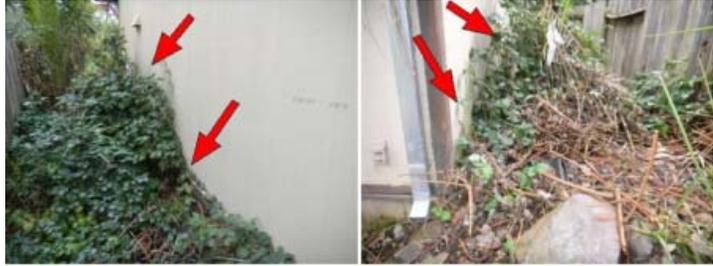
Vegetation or storage of belongings limited the viewing / inspection of exterior wall surfaces in some locations. Beware that challenges may be present which are outside the scope of this visual inspection. We recommend keeping vegetation trimmed back where it is in contact with exterior wall surfaces.

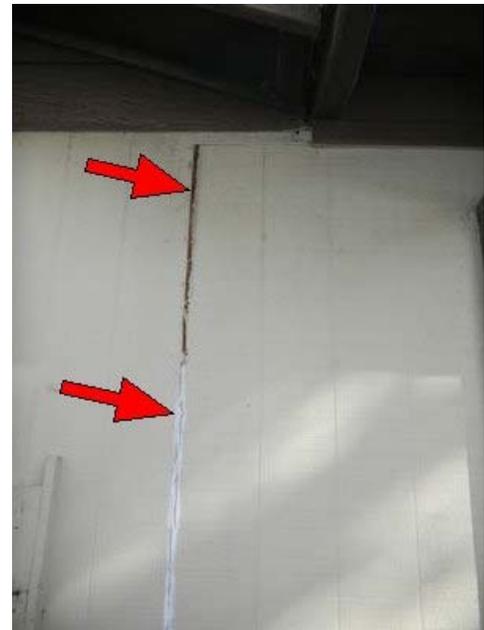
The siding at the left side of the house is observed to be pulled apart at one of the connection seams. I am unable to determine the cause of this condition.

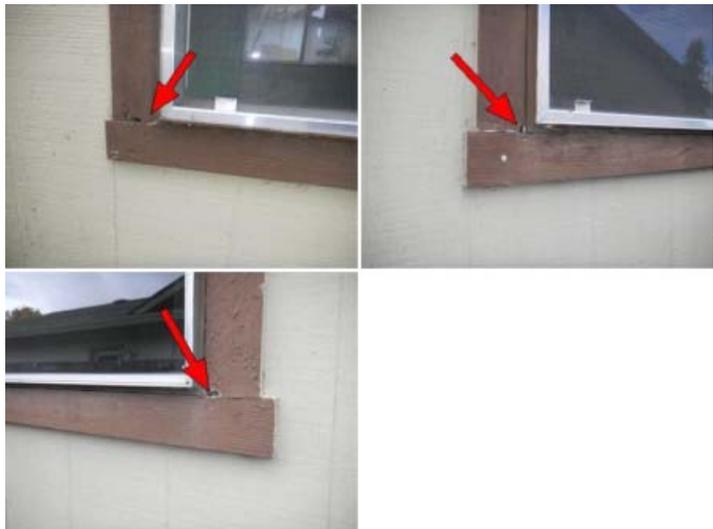
Good to Fair Condition. Wood. Damaged or deteriorated trim is noted at one or more locations around the structure (see pictures for examples).

Wood members were noted which are in contact with the soil or concrete. This condition will have an adverse affect on the duration of wood components. It is recommended to

have adequate separation between the ground and siding components.

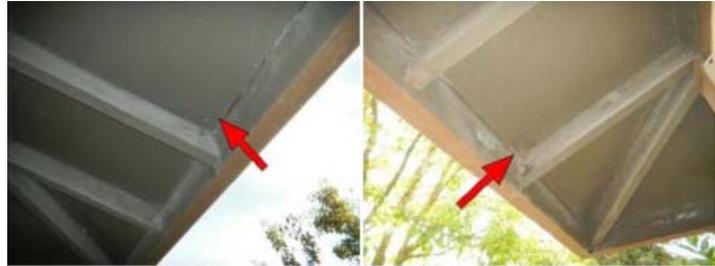
Fair condition.  
The roof sheathing at the eave overhangs is deteriorated at one or more locations along the front of the garage and house.  
Recommend having this condition evaluated and corrected by the appropriate qualified trades person.

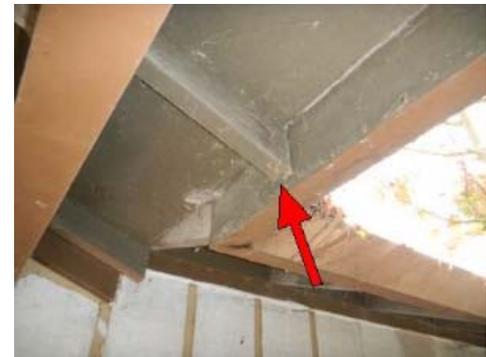
One or more of the rafter tails are deteriorated from moisture in the same areas as the deteriorated roof sheathing.  
Recommend having this condition evaluated and corrected by the appropriate qualified trades person.

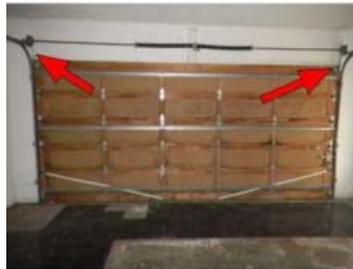
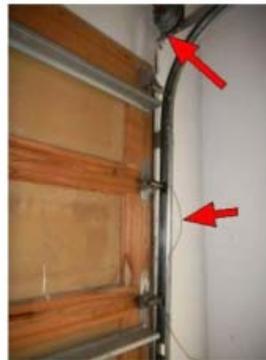
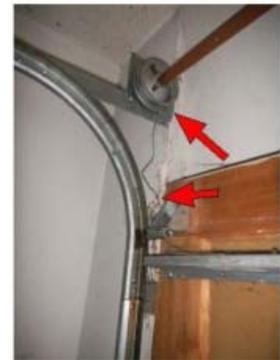
The physical operation of the overhead garage door was NOT TESTED as the door spring cables were broken. Recommend contacting a Garage Door service and repair company to make necessary repairs and adjustments.

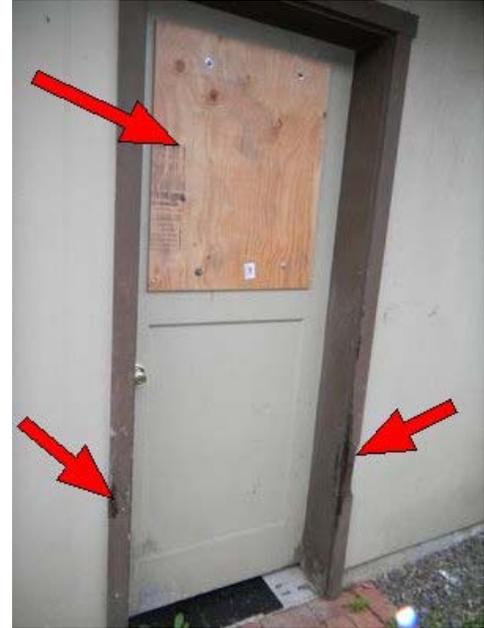
The window on the side door has been broken out and the opening is boarded closed.

The trim on the exterior of the door is damaged.
