Residential Property Inspections

Property Condition Report for: 555 Anywhere Avenue, Santa Rosa CA

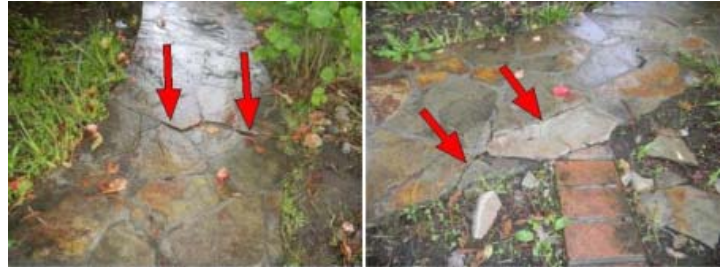
There were portions of the flagstone walkway where the flagstones are loose or missing. Recommend having this condition evaluated and corrected by the appropriate qualified trades person.

Walkway surfaces are noted to be raised or settled in some areas creating Potential Tripping Hazards.

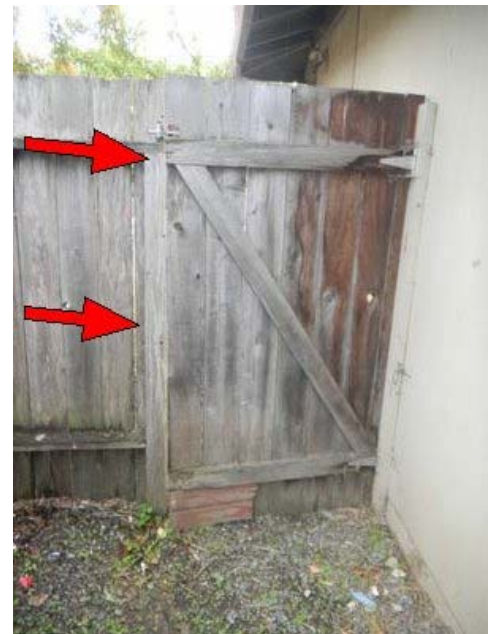
GATES: Fair condition
Right side gate is in need of repair or adjustment.

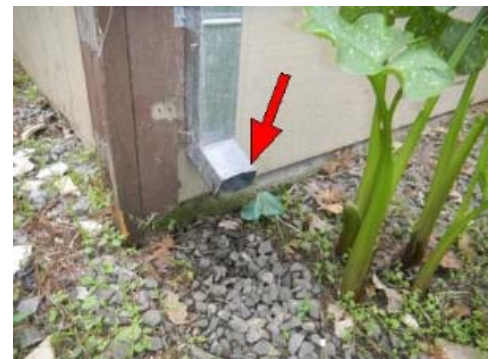
SITE GRADING: Gentle slope.
One or more down spouts do not have splash blocks or drain lines to carry water away from foundation. This condition will allow roof water to pool near the foundation which may lead to moisture challenges around the structure. We recommend that during periods of wet weather, some sort of splash blocks, or downspout extensions, etc. be installed to ensure that water will flow continuously away from the building.

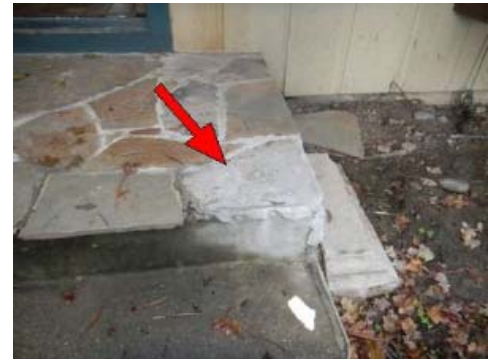
TYPE & CONDITION: Good to Fair Condition. Flagstone.
One or more flagstones are loose, or missing at the front porch. Recommend having this condition evaluated and corrected by the appropriate qualified trades person.

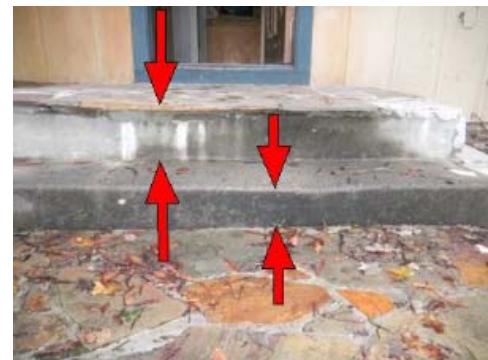
CONDITION: Good to Fair Condition.
Improper and un-even rise and tread ratios were noted at the stairs at the front of the structure. This is a Potential Tripping Hazard. The height of the individual risers (the vertical portion of the steps) typically should not vary more than 3/8".
