Residential Property Inspections

Property Condition Report for: 555 Anywhere Avenue, Santa Rosa CA

PLUMBING SYSTEM

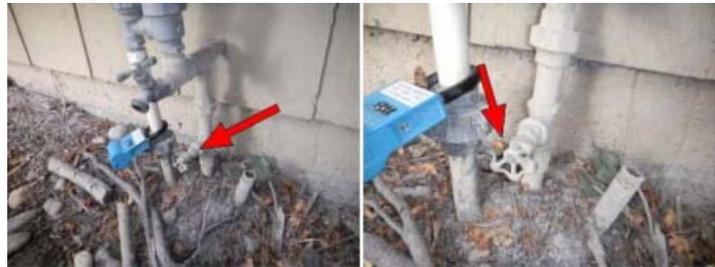
WATER SHUT-OFF: Located at the front of the house.
The main water shut-off valve handle at the front of the house is broken which may make it difficult to operate. Recommend having this condition evaluated and corrected by a licensed plumbing contractor.

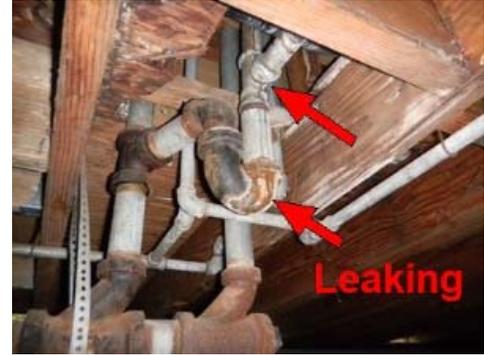
There was an active waste line leak visible from the under-floor crawlspace at the drain line for the hall bathroom bathtub.

Recommend having this condition evaluated and corrected by a licensed plumbing contractor.

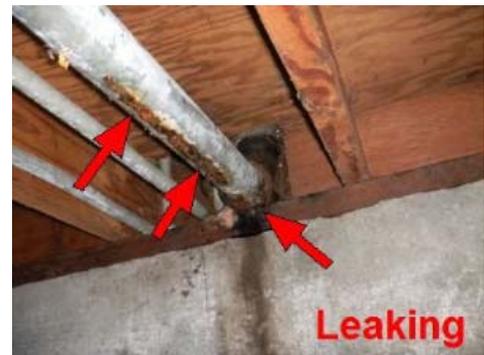
The galvanized drain line for the kitchen sink is completely rusted through and leaking as viewed from the under floor crawlspace.

Recommend having this condition evaluated and corrected by a licensed plumbing contractor.

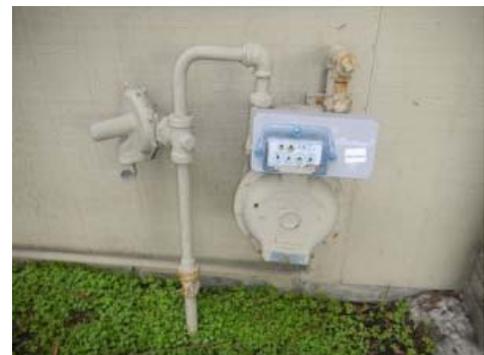
Natural gas meter and shut-off located at the left side of the house.

There was NO visible wrench with which to turn this shutoff valve. Gas valves are often very difficult to turn without a wrench at least 10" long, we suggest that a wrench be fastened within easy reach of this gas valve for use in the event of an emergency.

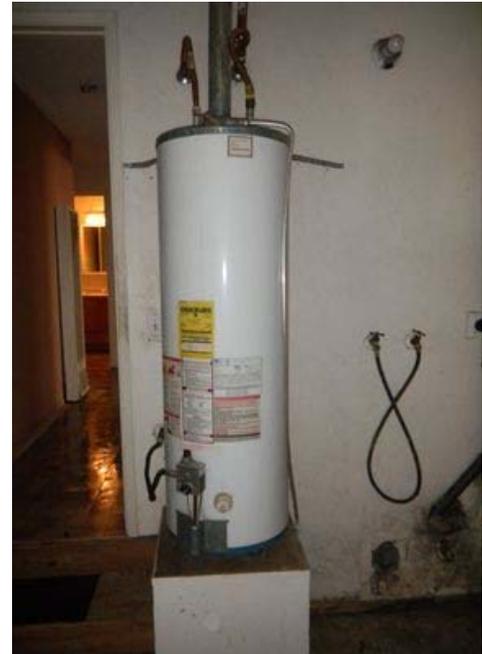
LOCATION: Located at the garage.

AGE: This unit appears to be 16 - 18 years old. Statistical average life of a water heater in the United States is approximately 10 years. They may exceed this life expectancy by many years depending on the minerals, etc. in the incoming water, also routine maintenance such as draining the tank annually can help extend the life.

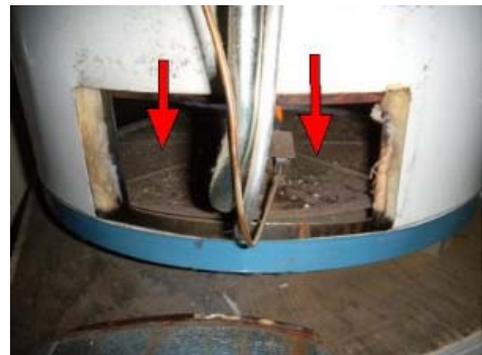
Rust Flakes were noted in the burner compartment. This is a common condition when water heaters are in garages as the outside temperatures can cause condensation in the burner compartment which leads to surface rusting.

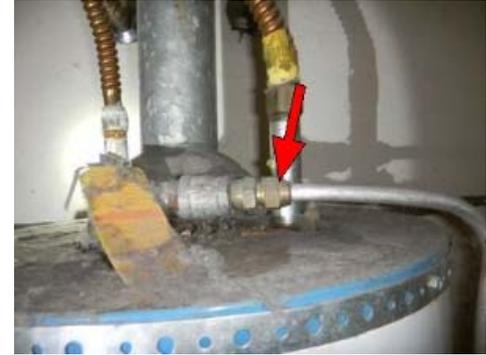
The diameter of the discharge opening for the Temperature & Pressure Valve (T&P) is 3/4". The diameter of the drain line installed is less than 3/4". When the T&P valve activates it will not allow the water to exit through the reduced diameter drain line quickly enough and cause back-pressure on the tank. This can be a Potential Hazard. Recommend contacting a licensed plumbing contractor to evaluate and repair this condition.

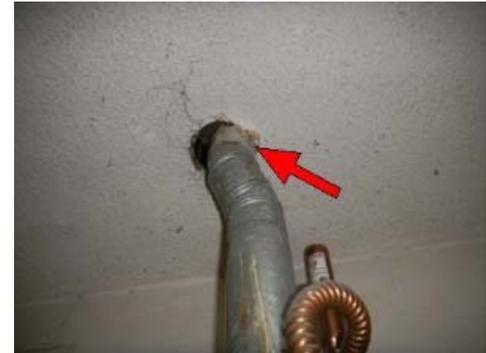
Improper clearance was noted from the exhaust pipe to combustible materials where the pipe goes through the wall or ceiling. This is a Potential Fire Hazard! The distance from the exhaust pipe to combustible materials should typically be at least one inch for dual wall pipes and 6" for single wall pipes. The paper on the back side of sheetrock IS a combustible material. This appears to be a single wall pipe.
