**Property Condition Report for: 555 Anywhere Avenue, Santa Rosa CA**

# ROOF SYSTEM

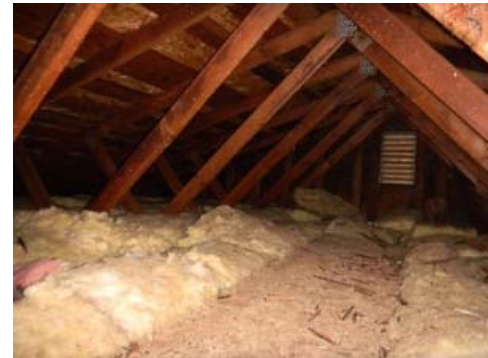
**STRUCTURE:** Good condition. Truss type construction.

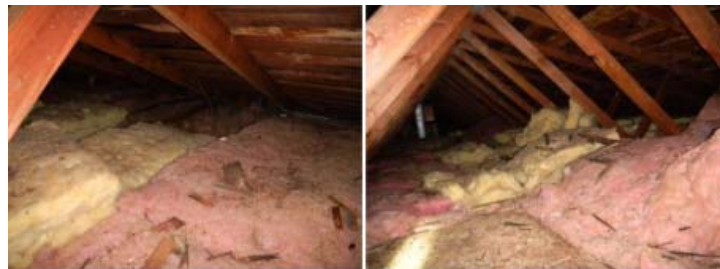
**INSULATION:** Good condition. Fiberglass Blown-in with Fiberglass Batting installed over the top in most places. Existing insulation value is approximately R-26.

NOTE: The standard for new home construction is R-30 to R-38 (depending on the other energy efficiency considerations of the building). There is no requirement at this time for upgrading to that standard.

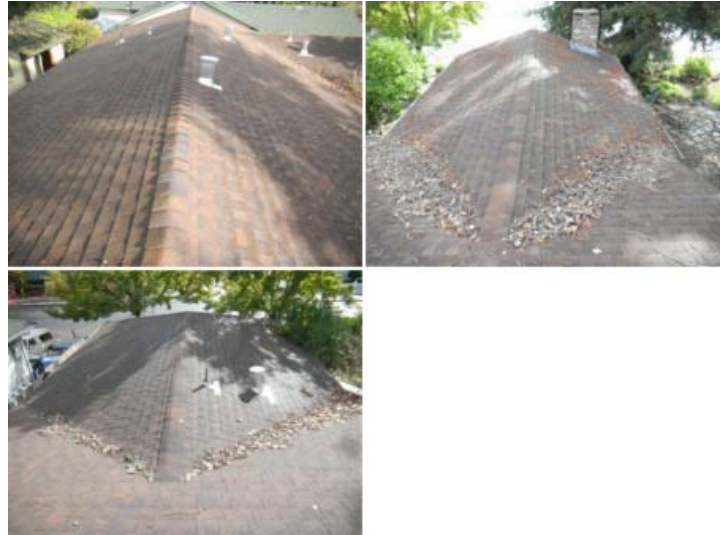
**ROOF PITCH(S):** The approximate roof pitch is 4:12.

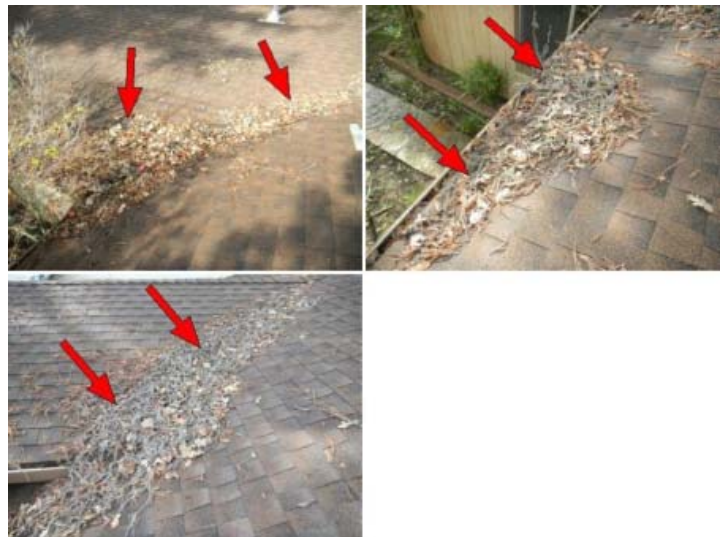
**TYPE & CONDITION:** Good to Fair Condition.  
The roof covering is Architectural Composition Shingles. Also called Dimensional Composition.

There are large amounts of debris (leaves, sticks, etc.) accumulating on the roof surfaces. We recommend that roof surfaces are cleaned on a regular basis.

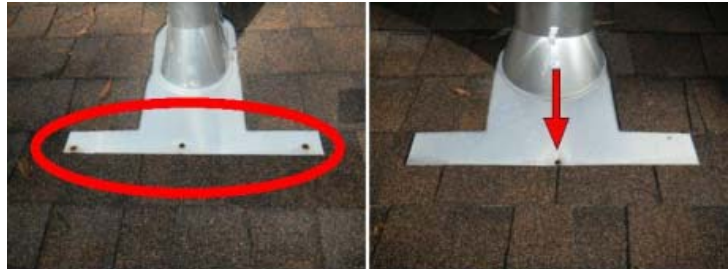
Good to Fair Condition.

Nails/fasteners were noted which are exposed to the elements. These fasteners may eventually come loose or rust. We recommend that they be sealed as a preventative measure against future leakage.

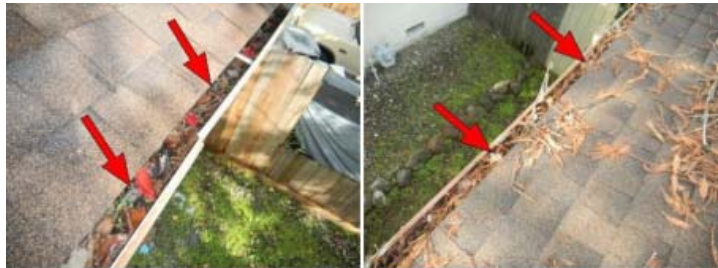
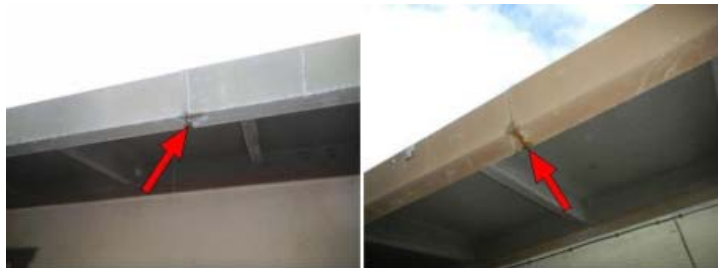
Fair condition. Metal.

Debris (from overhanging vegetation, mineral deposits from roof shingles, etc.) is noted in the gutters. This is a common condition, however it will accelerate deterioration of gutters.

The gutters are leaking at one or more joints, end caps, or connections to downspouts as evident by visible rust staining or water marks.

Gutter cleaning is a preventative maintenance procedure which should be performed at least once a year.

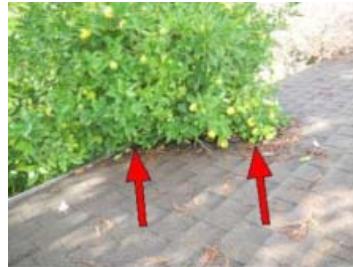
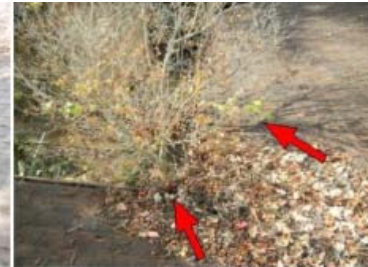
Trees or shrubbery are over hanging the roof surface(s). We recommend that overhanging vegetation be trimmed back anywhere it is likely to come into contact with the roof or eaves.
