Property Condition Report for: 555 Anywhere Avenue, Santa Rosa CA

ELECTRICAL SYSTEM

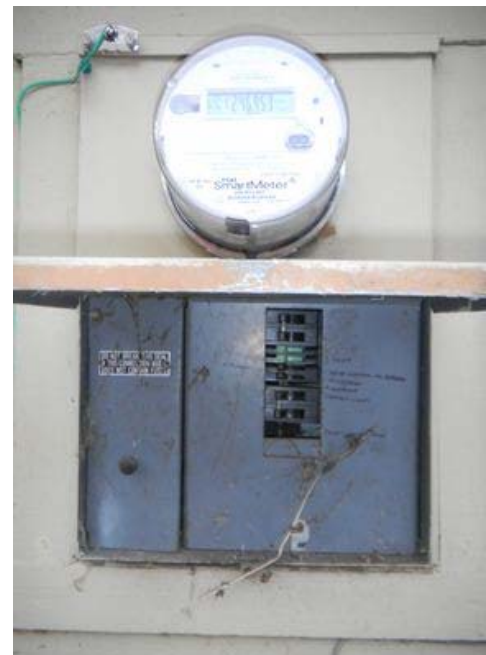
- LOCATION:** Located at the right side of the garage.

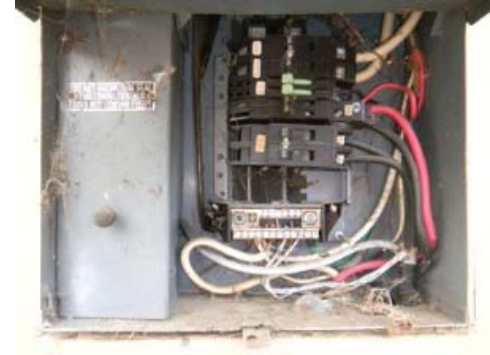
Fair condition.
The front dead-face cover was removed and the internal visible wiring was viewed. NO wires were touched or moved during the visual inspection of the internal components.

A Zinsco brand circuit breaker panel is noted to be present. Many experts in the electrical industry believe these panels are hazardous and should be replaced. There is a body of evidence which suggests that these panels and circuit breakers are less than reliable. This is a controversial subject and experts differ in opinions. I believe that replacing the panel with a new modern panel would be the safest course of action. I recommend consulting with a licensed electrician who is familiar with Zinsco panels to determine what action is to be taken.

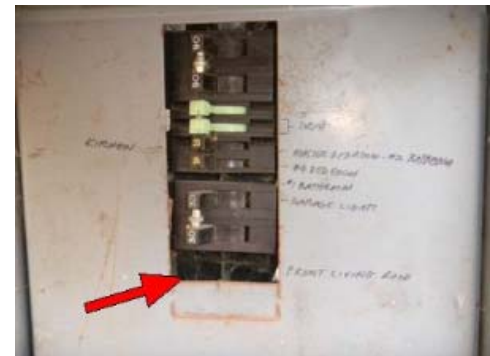
There is an unused circuit breaker opening in this panel that does not have a proper protective cover installed. These covers can be either plastic or metal and are typically called knock-outs. They simply clip into place without the use of any tools. These covers are important because without them, someone could stick their fingers into the panel and come into direct contact with high voltage. Recommend having this condition evaluated and corrected by a licensed electrician.

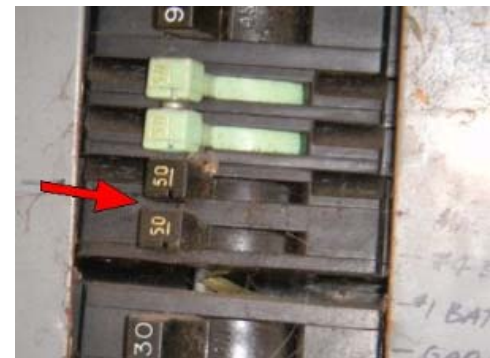
One or more 220 volt breaker handle(s) are missing the handle tie(s). The handle tie is a small pin or clip that connects both halves of the breaker so that they both trip together. This condition could do damage to the major appliance it serves if one half of the breaker trips without the other.

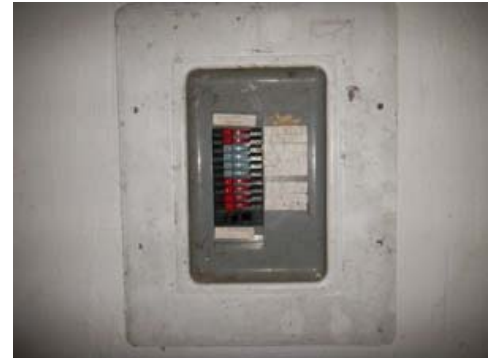
LOCATION: Interior of the structure at the garage.

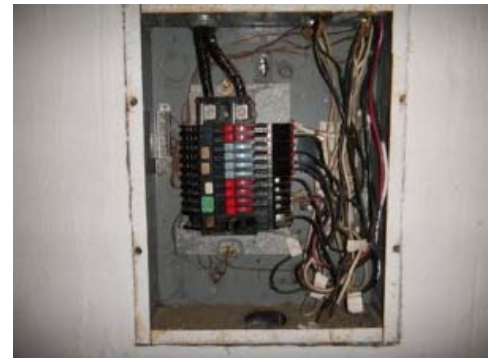
CONDITION: Fair condition.
The front dead-face cover was removed and the internal visible wiring was viewed. NO wires were touched or moved during the visual inspection of the internal components.

A Zinsco brand circuit breaker panel is noted to be present. Many experts in the electrical industry believe these panels are hazardous and should be replaced. There is a body of evidence which suggests that these panels and circuit breakers are less than reliable. This is a controversial subject and experts differ in opinions. I believe that replacing the panel with a new modern panel would be the safest course of action. I recommend consulting with a licensed electrician who is familiar with Zinsco panels to determine what action is to be taken.

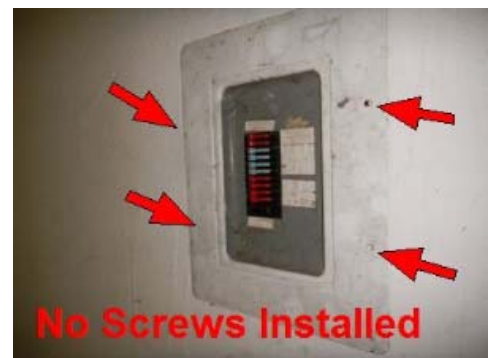
One or more of the dead face cover screws or fasteners are missing. Recommend the addition of appropriate fasteners to secure the front panel cover in place.

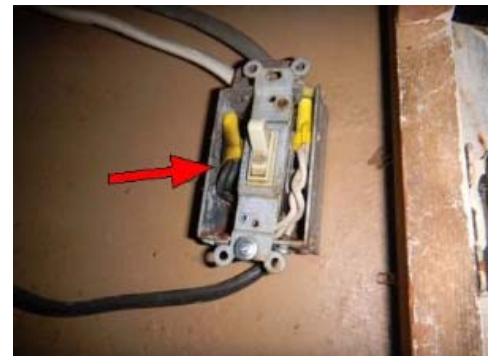
[Missing face plate was noted at one interior outlet. This is an inexpensive repair however it is very important because the lack of a face plate exposes the live conductors and can also allow sparks to escape the outlet or switch box. Recommend the immediate installation of a proper faceplate.](#)

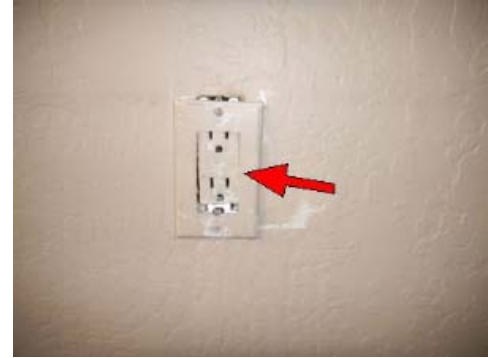
One or more switches or outlets were noted to be loose. Either they are not securely fastened to the junction box, or the junction box is not tight at the connection to the interior wall framing member. Recommend having this condition evaluated and corrected by a licensed electrician.

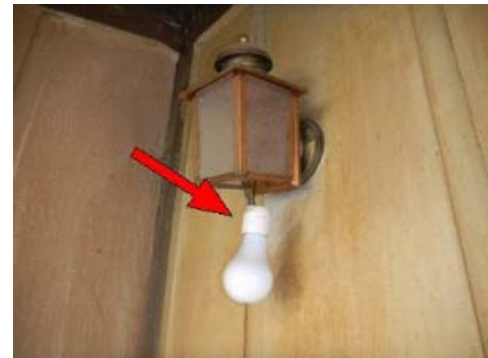
The exterior light at the front porch is damaged and the light bulb is being held up with the wires. Recommend having this condition evaluated and corrected by a licensed electrician.
