## Residential Property Inspections

**Property Condition Report for: 555 Anywhere Avenue, Santa Rosa CA**

# HEATING & COOLING SYSTEMS

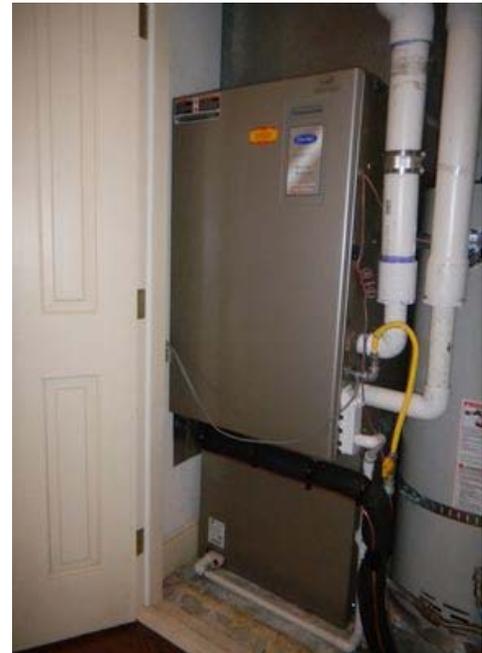
**LOCATION:** Located at the hall closet at the left side of the house.

**BRAND NAME** Carrier.

**AGE OF FURNACE:** Less than 2 Years.

**DATE OF MANUFACTURE:** Based on the manufacturers label, we have attempted to determined the year that this unit was manufactured. Based on that information, the year of manufacture was 2009.

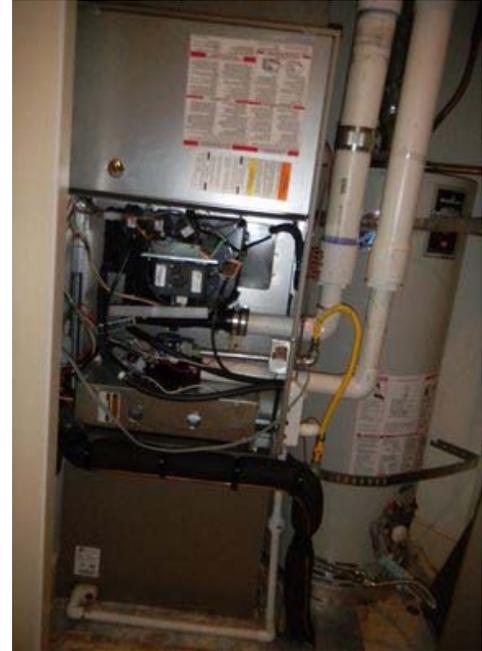
**BONUS FEATURE! This furnace has been upgraded from the original.**

Good condition. The furnace responded to operation by the thermostat control and appeared to be operating properly.

The utility company recommends that furnaces be serviced by a licensed technician at least once every year. We recommend you contact the local utility company (PG&E) to check this appliance for function and safety, this is usually a free service. The lack of proper service and maintenance, (such as the removal of dust from around the fan motor) can result in premature failure of the heating system components.

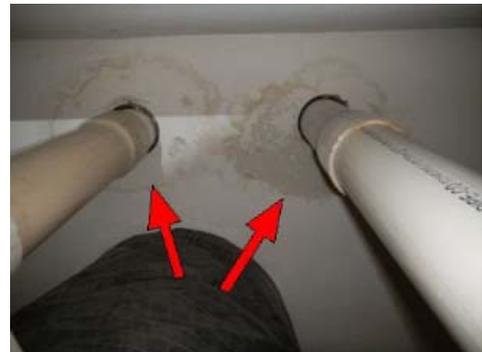
Good to Fair Condition.

Water staining is noted to the ceiling around the exhaust vent. These stains APPEAR to be the result of past, rather than current roof leakage. However it is not possible to be absolutely certain.

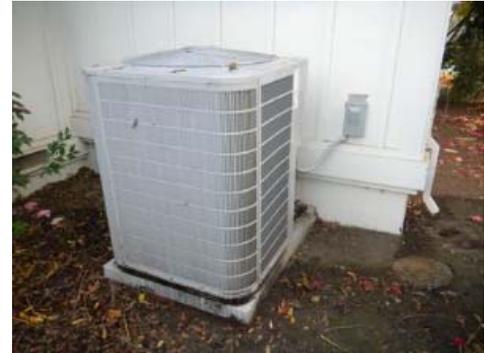
**LOCATION:** Outdoors rear of the house towards the left end.

- BRAND NAME** Carrier.
- AGE OF UNIT:** Less than 2 Years.
- DATE OF MANUFACTURE:** Based on the manufacturers label, we have attempted to determined the year that this unit was manufactured. Based on that information, the year of manufacture was 2009.
