# KITCHENS & LAUNDRY

## Residential Property Inspections

### Property Condition Report for: 555 Anywhere Avenue, Santa Rosa CA

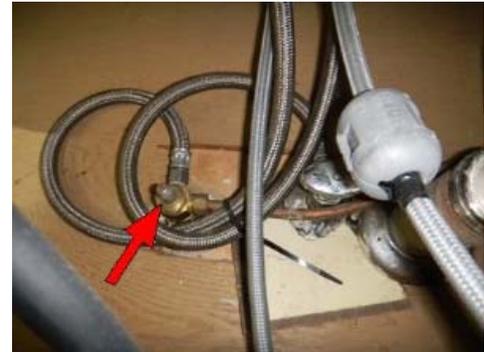
**FAUCET(S):** Good to fair condition.  
One of the water supply lines under the sink is missing a shut-off handle. Recommend having this condition evaluated and corrected by the appropriate qualified trades person.

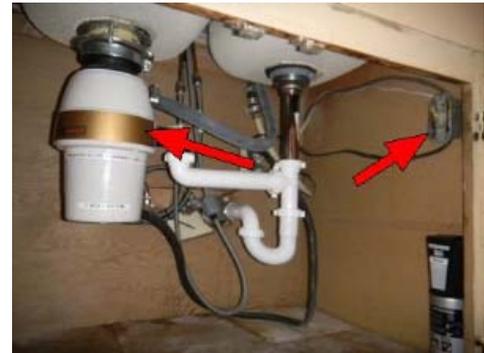
**GARBAGE DISPOSAL:** Good to Fair Condition.  
The switch for the garbage disposal unit is mounted low inside one of the under sink cabinets. This is a Potential Hazard as someone (a child) could turn this unit on when someone else is using the sink.

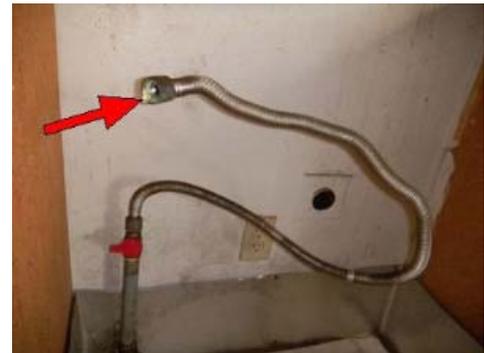
**RANGE/BURNERS:** None.  
Natural gas connection is present.  
The gas line present has a shut-off valve installed however there is NO cap on the end fitting of the gas line. A cap is recommended to prevent accidental gas leakage in the event the gas valve gets turned "on". Recommend having this condition evaluated and corrected by a licensed plumbing contractor.

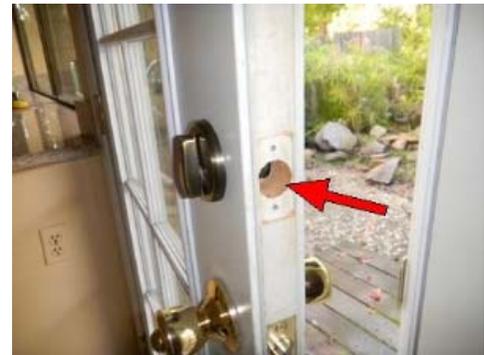
- REFRIGERATOR:** None present.
- DOORS:** Good to Fair Condition.  
The deadbolt is missing components and does not function as designed. Recommend having this condition evaluated and corrected by the appropriate qualified trades person.

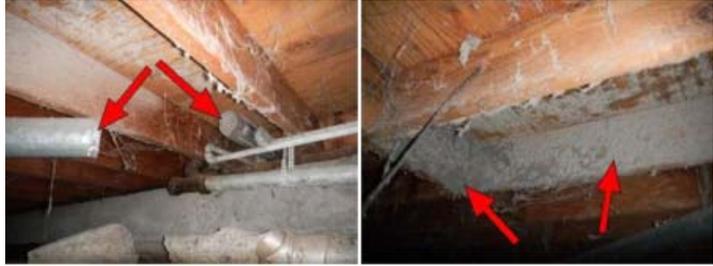
Dryer venting is provided. We recommend that you routinely check the airflow at the dryer venting as restriction or lint accumulation can be a fire hazard.

The dryer vent ends or is disconnected in the crawlspace and does not extend to the exterior of the structure. This not only allows excessive moisture to be exhausted under the structure, but the accumulation of lint is a Potential Fire Hazard. Recommend having this condition evaluated and corrected by the appropriate qualified trades person.

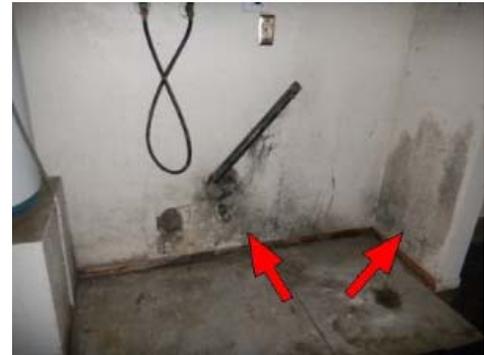
Fair condition. Painted.  
Evidence of a past moisture challenges is noted to the wall and flooring in the laundry areas. This area was dry at the inspection and appears to have been caused by a past moisture challenge. I am unable to determine the extent of this condition without destructive discovery. Beware that conditions may exist that extend into inaccessible areas. Destructive discovery is outside the scope of this limited visual inspection.
